**Flood Control Project Maintenance  
Levee Inspections****LMA District Cover Sheet****Spring 2014 Levee Inspection Results****Reclamation District No. 0765 Glide**

**Levee Inspection Report By Mile - Spring 2014**

Waterway	Bank	Unit Miles	Inspection Start/End	Inspector
Unit No. 01 Sacramento River	Right	1.74	03/03/2014 03/03/2014	Richard Willoughby

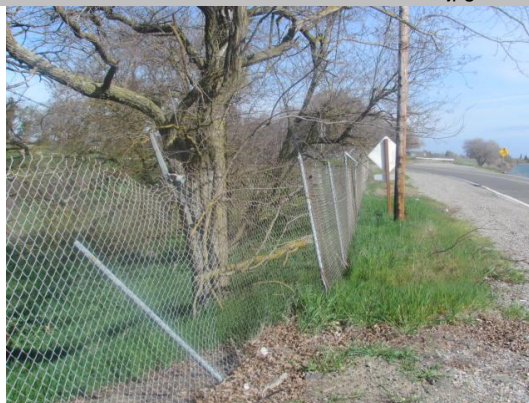
Photo 1 of 1 : richard\_s\_20140303\_065.jpg

Looking north (upstream) at trees on landside slope.

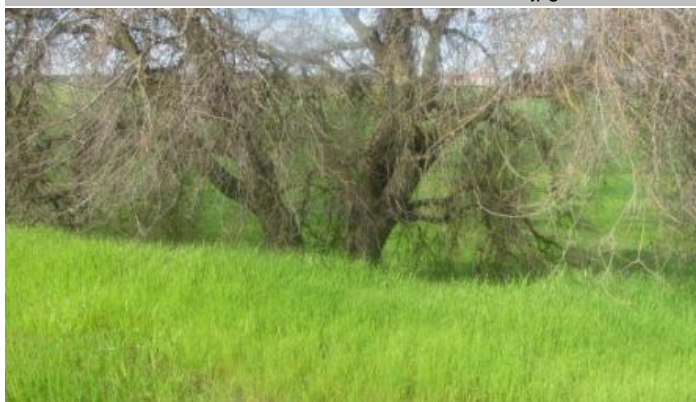
Photo 1 of 2 : richard\_s\_20140303\_088.jpg

Looking west at trees on landside toe.

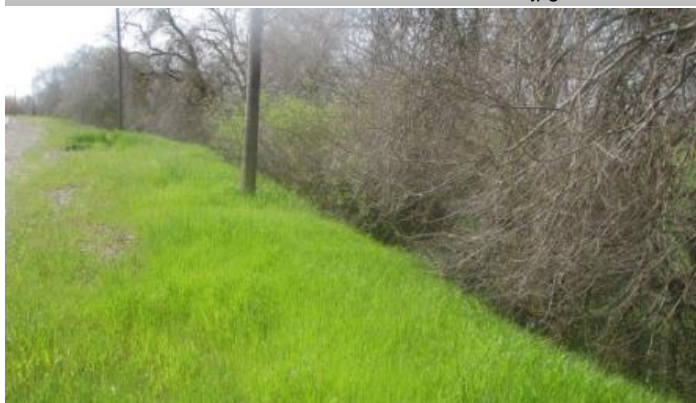
Photo 2 of 2 : richard\_s\_20140303\_089.jpg

Looking downstream (south) at trees on landside slope & toe.

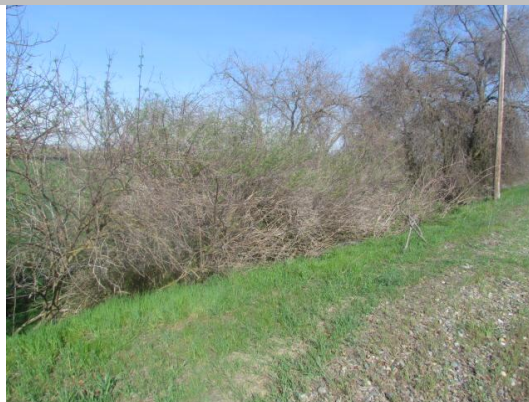
Photo 1 of 1 : richard\_s\_20140303\_086.jpg

Looking northwest at dense vegetation on landside slope.

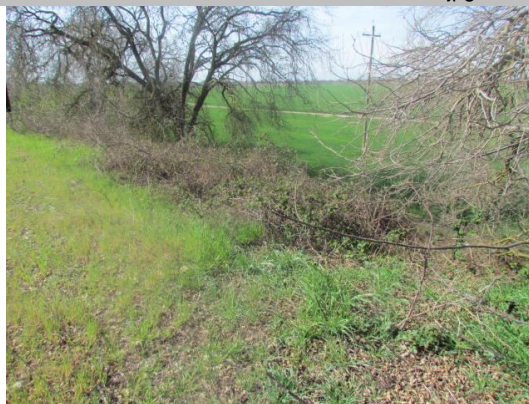
Photo 1 of 1 : richard\_s\_20140303\_108.jpg

Looking at wild berryvines or wild roses on landside slope and toe.

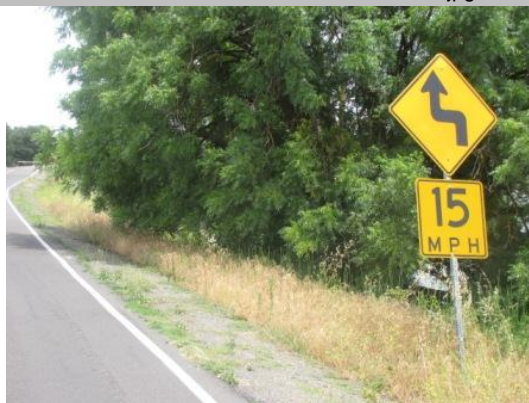
Photo 1 of 5 : richard\_s\_20140303\_072.jpg

Looking northeast at overgrown trees on waterside slope.

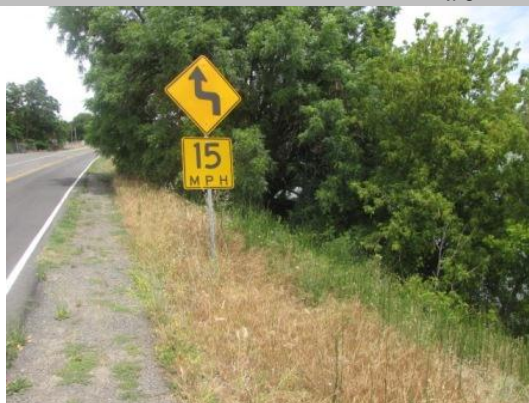
Photo 2 of 5 : richard\_s\_20140303\_073.jpg

Looking north at dense trees on waterside slope from fall 2010 inspection.

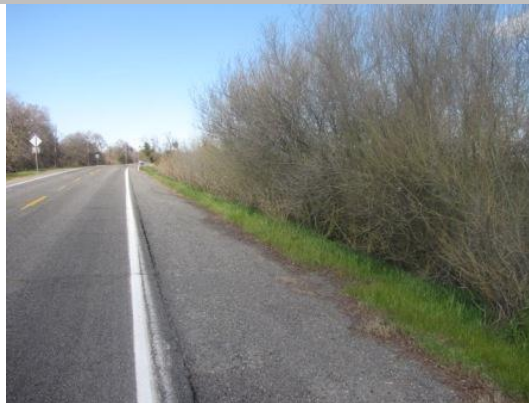
Photo 3 of 5 : richard\_s\_20140303\_074.jpg

Looking upstream (north) at dense vegetation and trees from 2011 spring inspection.

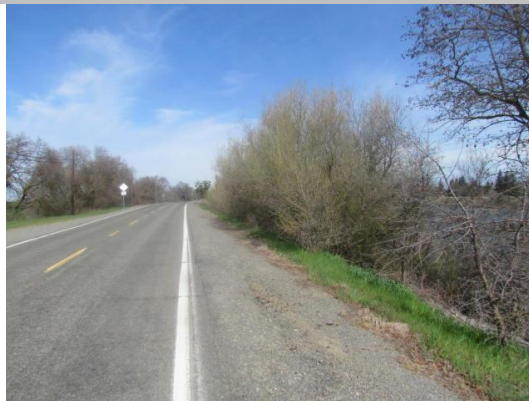
Photo 4 of 5 : richard\_s\_20140303\_075.jpg

Looking north (upstream) at dense trees on landside slope and shoulder. (Spring 2013)

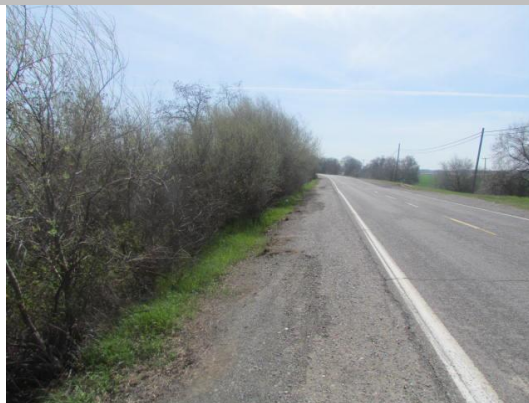
Photo 5 of 5 : richard\_s\_20140303\_076.jpg

Looking south (downstream) at dense trees on landside slope and shoulder. (Spring 2013)

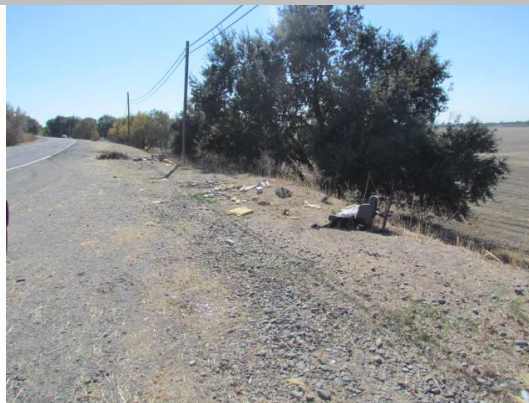
Photo 1 of 1 : richard\_s\_20140303\_112.jpg

LM Start	0.26	Rating **	A/W	Issue No.	54
LM End	0.26	Issue Type +	En	Location *	LS
Category	Earthen Levee			GPS Latitude/Longitude	
				Start	End
Item	Encroachments			38.499177 °	38.499177 °
				-121.560488 °	-121.560488 °
DWR ID	DWR_RD0765_01_f _ 2013_54				
Action/Comments					
Garbage

Looking southwest at garbage on landward shoulder and slope.

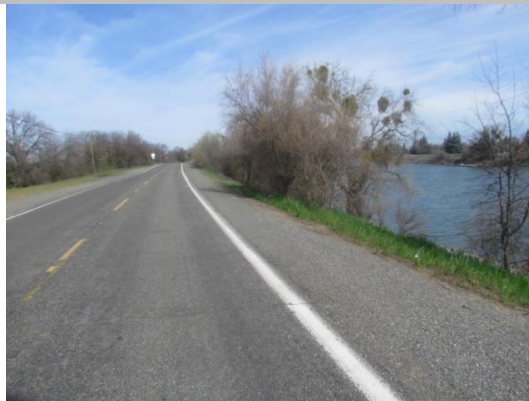
Photo 1 of 1 : richard\_s\_20140303\_087.jpg

Looking north (upstream) at untrimmed trees on waterside shoulder and slope.

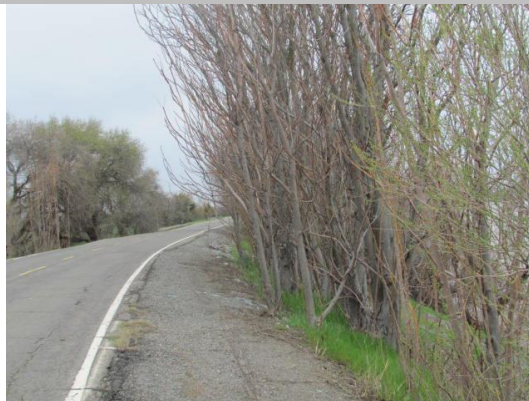
Photo 1 of 1 : richard\_s\_20140305\_136.jpg

Looking north (upstream) at untrimmed trees on waterward slope.

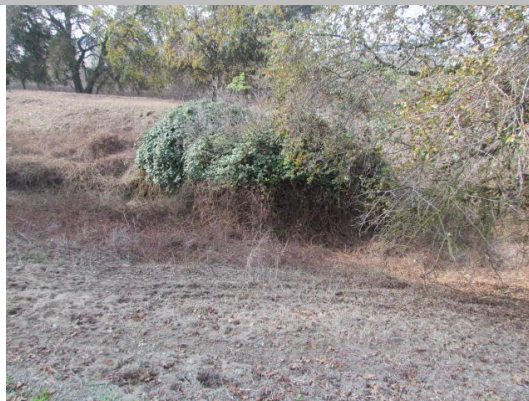
Photo 1 of 1 : richard\_s\_20140303\_106.jpg

LM Start	0.41	Rating **	U	Issue No.	47
LM End	0.41	Issue Type +	Ma	Location *	LS
Category	Earthen Levee			GPS Latitude/Longitude	
				Start	End
Item	Vegetation			38.497069 °	38.497069 °
				-121.560106 °	-121.560106 °
DWR ID	DWR_RD0765_01_f _ 2012_47				
Action/Comments					
Remove the wild growth other than native grasses from the levee slopes.					
Inspector Comments: Wild berryvines on landside toe.

Looking west at dense berryvines on landside toe.

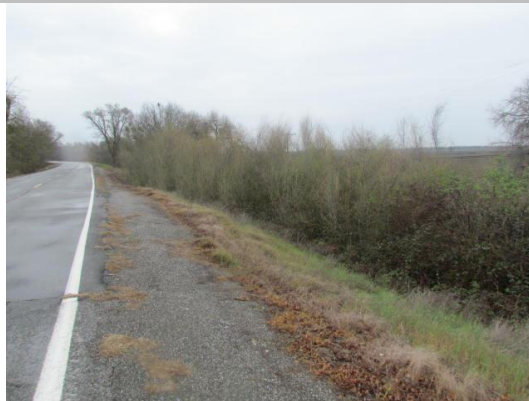
Photo 1 of 1 : richard\_s\_20140303\_093.jpg

LM Start	0.43	Rating **	M	Issue No.	32
LM End	0.47	Issue Type +	Ma	Location *	LS
Category	Earthen Levee			GPS Latitude/Longitude	
				Start	End
Item	Trim / Thin Trees			38.496792 °	38.496321 °
				-121.560026 °	-121.559842 °
DWR ID	DWR_RD0765_01_s _ 2012_32				
Action/Comments					
Trim and thin trees to allow visibility of the ground and room to flood fight.

Looking southwest at dense vegetation on landside slope and toe.

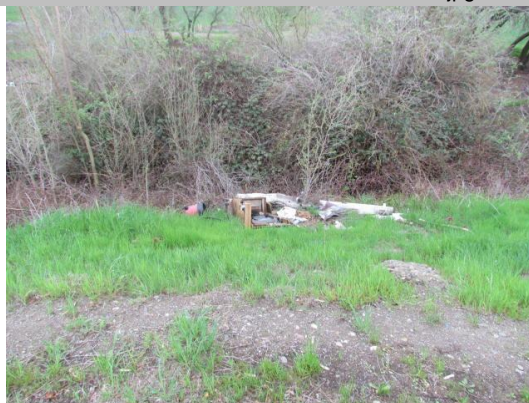
Photo 1 of 2 : richard\_s\_20140305\_137.jpg

Looking west at garbage on landside slope.

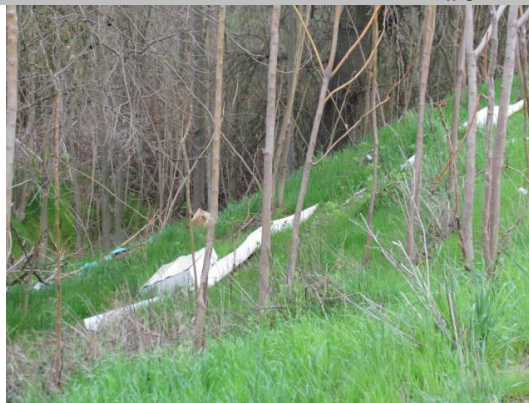
Photo 2 of 2 : richard\_s\_20140305\_138.jpg

Looking northwest at garbage on landside slope.

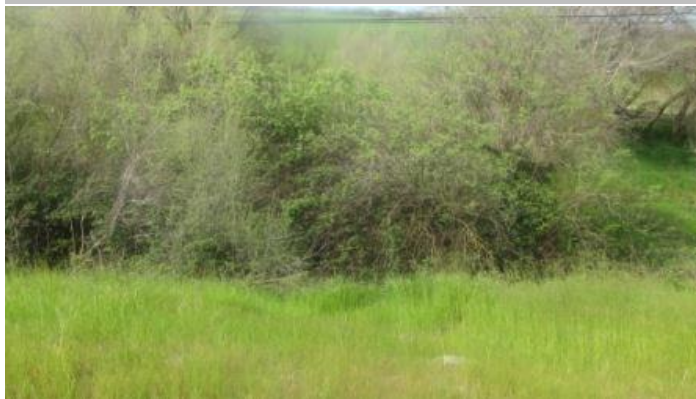
Photo 1 of 5 : richard\_s\_20140303\_094.jpg

LM Start	0.48	Rating **	U	Issue No.	33
LM End	0.50	Issue Type +	Ma	Location *	LS
Category	Earthen Levee			GPS Latitude/Longitude	
				Start	End
Item	Vegetation			38.496217 °	38.495855 °
				-121.559788 °	-121.559586 °
DWR ID	DWR_RD0765_01_s_2012_33				
Action/Comments					
Remove the wild growth other than native grasses from the levee

Looking northwest at trees on landside toe from 2010 fall inspection.

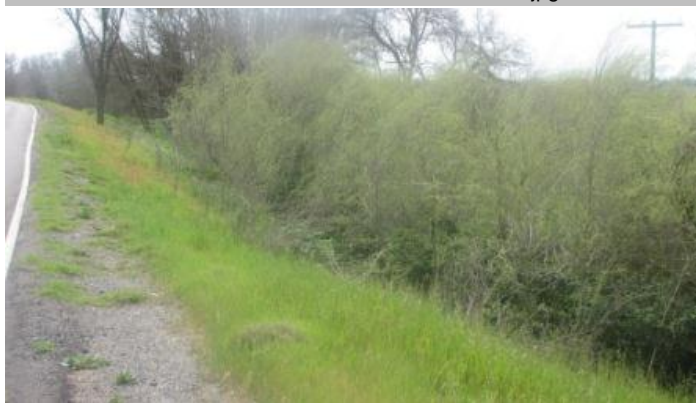
Photo 2 of 5 : richard\_s\_20140303\_095.jpg

Looking downstream (south) at trees on landside slope & toe.

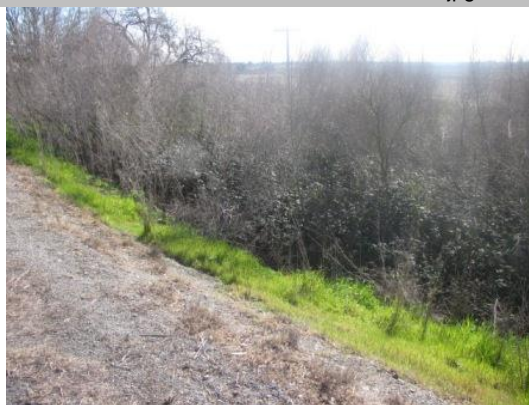
Photo 3 of 5 : richard\_s\_20140303\_096.jpg

Looking downstream (southwest) at dense vegetation on landside slope.

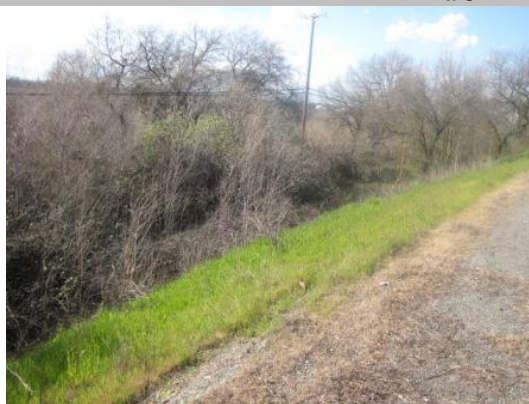
Photo 4 of 5 : richard\_s\_20140303\_097.jpg

Looking upstream (northwest) at dense vegetation on landside slope.

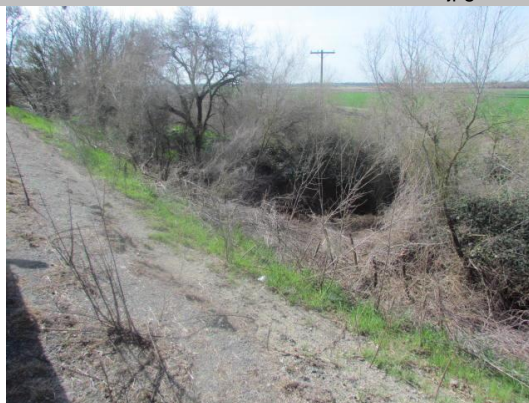
Photo 5 of 5 : richard\_s\_20140303\_098.jpg

Looking southwest at dense vegetation on landside slope and toe.

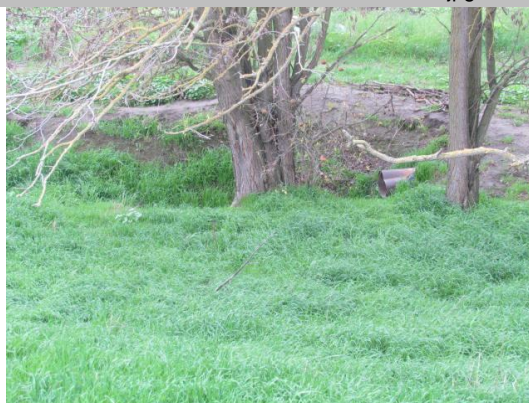
Photo 1 of 2 : richard\_s\_20140305\_139.jpg

LM Start	0.54	Rating **	M	Issue No.	56
LM End	0.71	Issue Type +	En	Location *	LS
Category	Earthen Levee			GPS Latitude/Longitude	
				Start	End
Item	Encroachments			38.495350 °	38.493303 °
				-121.559300 °	-121.557620 °
DWR ID	DWR_RD0765_01_f_2013_56				
Action/Comments					
Ditch Inspector Comments: Irrigation ditch at landward toe.

Looking west at irrigation ditch at landward toe.

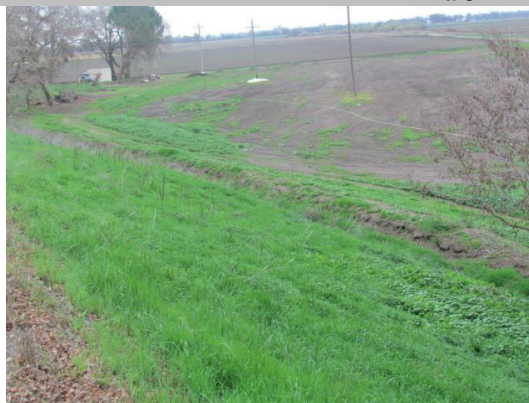
Photo 2 of 2 : richard\_s\_20140305\_140.jpg

Looking southwest at irrigation ditch running along landward toe.

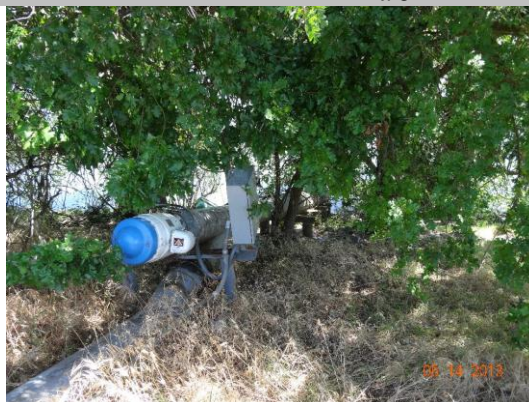
Photo 1 of 1 : UCIP\_1848.jpg

LM Start	0.55	Rating **	M	Issue No.	2
LM End	0.55	Issue Type +	En	Location *	LS
Category	Supplemental			GPS Latitude/Longitude	
				Start	End
Item	DWR UCIP Field Study			38.495263 °	38.495263 °
				-121.559194 °	-121.559194 °
DWR ID	DWR_RD0765_01_s _ 2014_2				
Action/Comments					
Inspector Comments: FS_ID:19578					
EP_NO: 3314					
Repair Type:					
Crossing Status:					
UCIP Comments:					
FIELD_STRUCT_DESC: 16-inch steel pipe hthrough the levee, 4.0 feet below the crown. Cutoff wall around pipe at center of levee. Slant pump on the waterward slope, with 22-inch inlet pipe extending from channel. 16-inch pipe connects to 12-inch steel pipe at landward shoulder, extending to concrete standpipe discharge outlet at the toe. Cobble revetment on waterward slope. (Permit No. 3314-1960)					
FS Date: 5/14/2013

View of waterward side--pipe, pump, control panels, and electrical conduit.

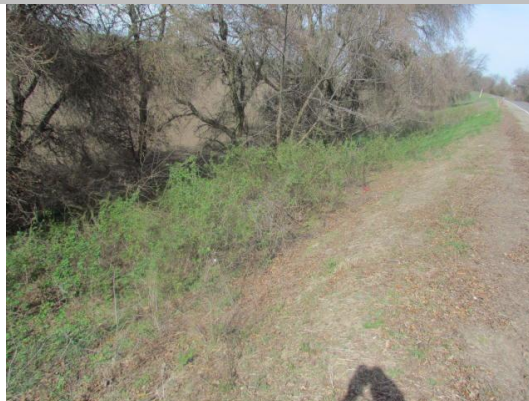
Photo 1 of 1 : richard\_s\_20140303\_109.jpg

Looking northwest at vegetation on landside slope.

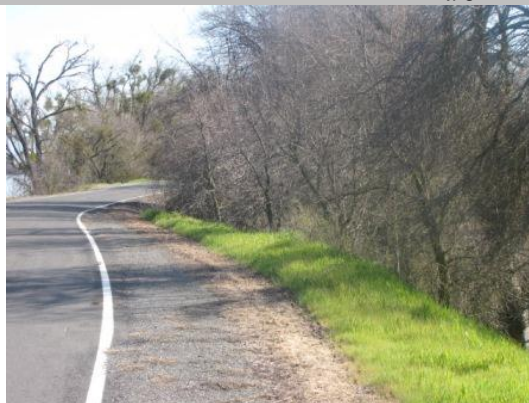
Photo 1 of 6 : richard\_s\_20140303\_079.jpg

Looking downstream (south) at dense trees on landside slope and toe.

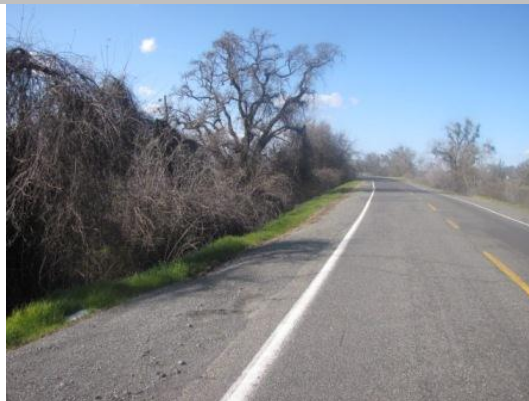
Photo 2 of 6 : richard\_s\_20140303\_080.jpg

Looking upstream (north) at dense trees on landside slope and toe.

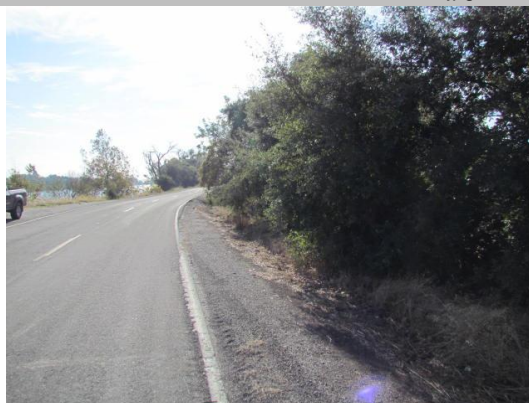
Photo 3 of 6 : richard\_s\_20140303\_081.jpg

Looking south at dense trees on landside shoulder and slope.  
(November 2011)

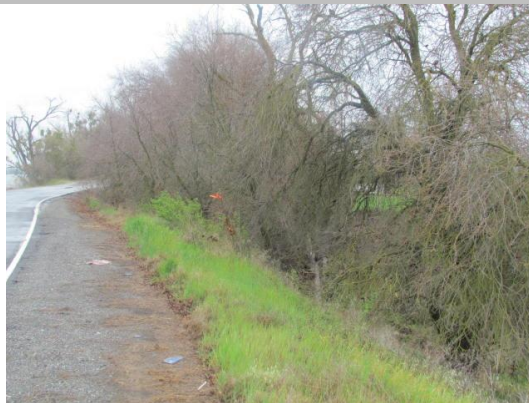
Photo 4 of 6 : richard\_s\_20140303\_082.jpg

Looking southwest at dense trees on landside slope and toe spring 2012.

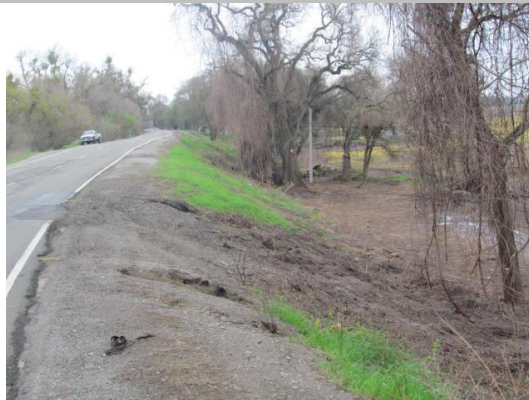
Photo 6 of 6 : richard\_s\_20140305\_141.jpg

Looking south at trimmed trees and vegetation on landside slope and toe.

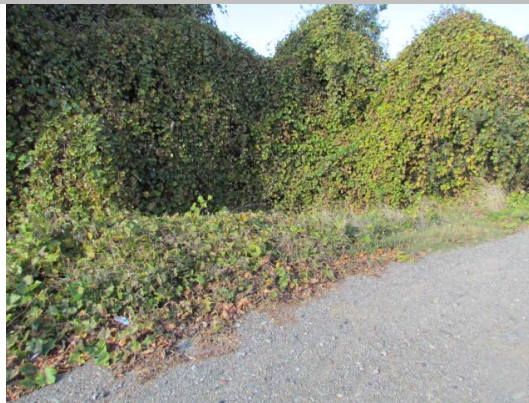
Photo 1 of 5 : richard\_s\_20140303\_117.jpg

Looking west at dense berryvines and wildroses on landside shoulder and slope. (November 2011)

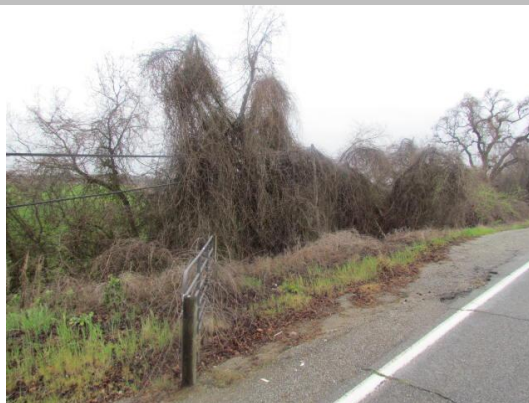
Photo 2 of 5 : richard\_s\_20140303\_118.jpg

Looking northwest at vines on landside toe spring 2012.

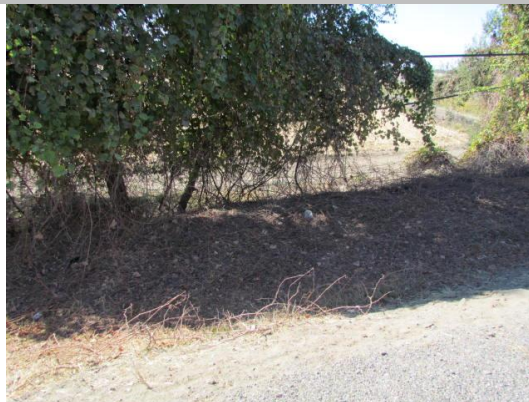
Photo 3 of 5 : richard\_s\_20140303\_119.jpg

Looking west at trimmed trees on landward slope.

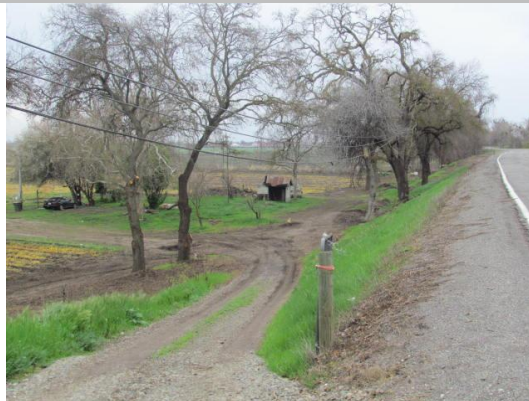
Photo 5 of 5 : richard\_s\_20140305\_143.jpg

Looking northwest at trimmed trees and vegetation on landside slope and toe.

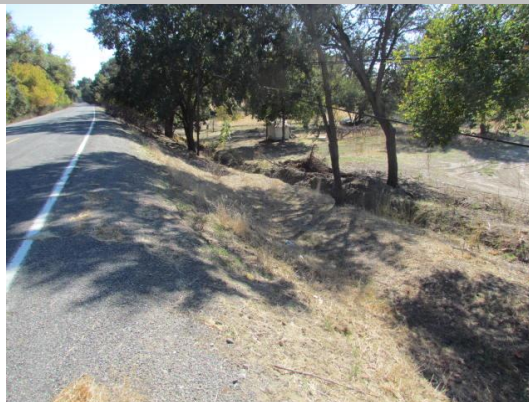
Photo 1 of 1 : richard\_s\_20140303\_110.jpg

Looking southwest at irrigation ditch on landward toe.

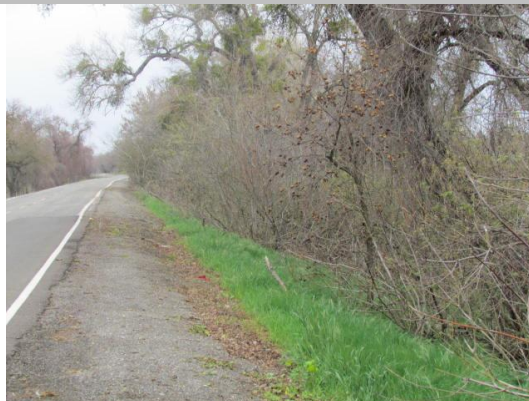
Photo 1 of 2 : richard\_s\_20140305\_134.jpg

Looking north (upstream) at untrimmed trees on waterward slope.

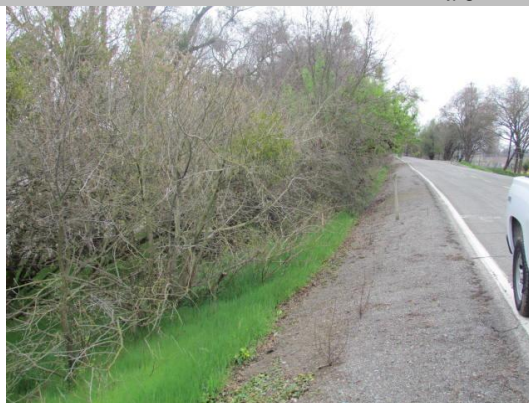
Photo 2 of 2 : richard\_s\_20140305\_135.jpg

Looking south (downstream) at untrimmed trees on waterward slope.

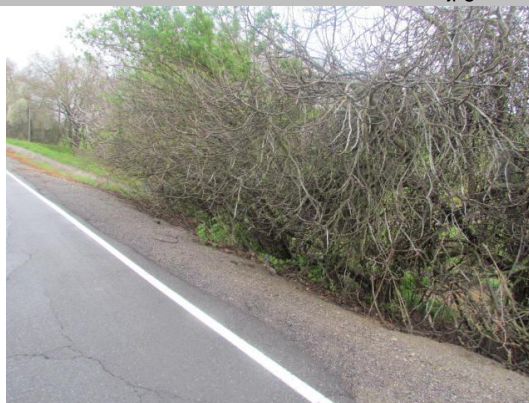
Photo 1 of 1 : richard\_s\_20140303\_104.jpg

Looking southwest at fig trees and other trees on landside slope and toe.

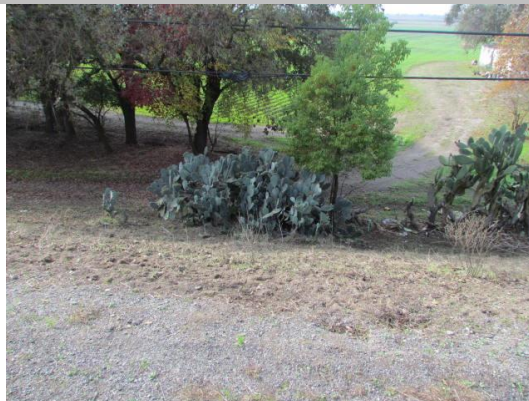
Photo 1 of 1 : richard\_s\_20140303\_078.jpg

Looking west at cactus at landside toe.

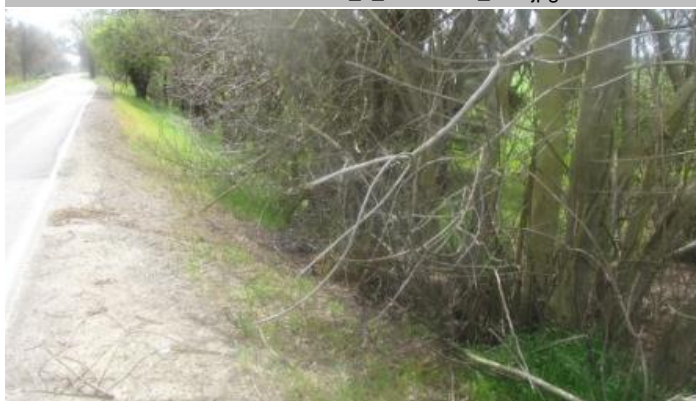
Photo 1 of 4 : richard\_s\_20140303\_099.jpg

Looking downstream (south) at trees on landside slope &amp; toe from 2010 fall inspection.

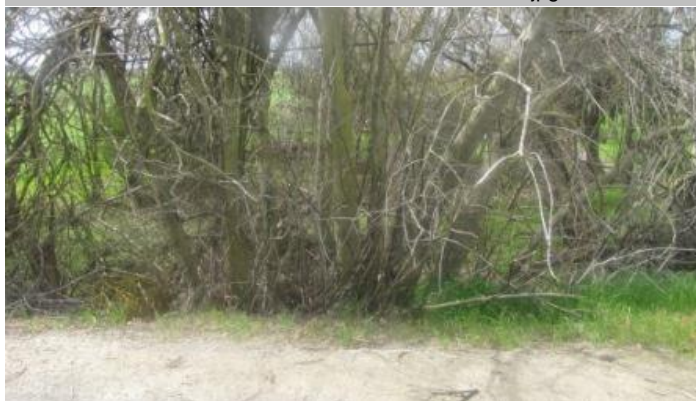
Photo 2 of 4 : richard\_s\_20140303\_100.jpg

Looking west at trees on landside slope &amp; toe.

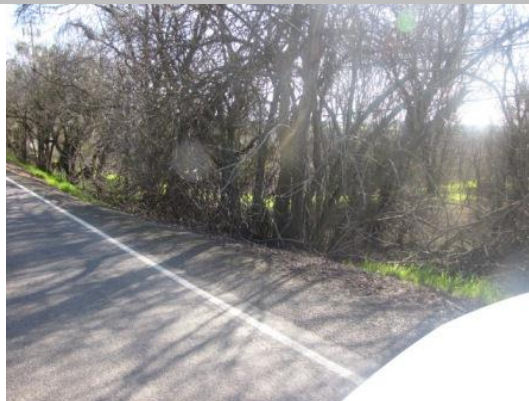
Photo 3 of 4 : richard\_s\_20140303\_101.jpg

Looking downstream (southwest) at dense trees on landside slope and toe.

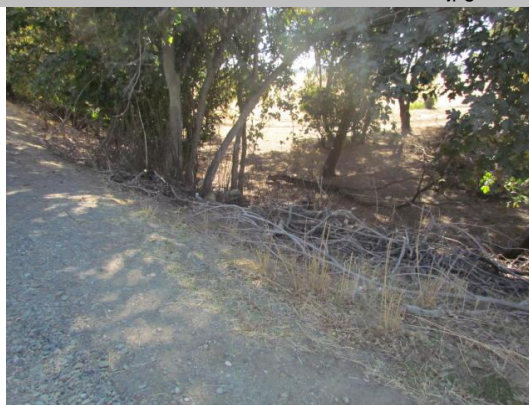
Photo 4 of 4 : richard\_s\_20140303\_102.jpg

Looking southwest at trees on landward slope.

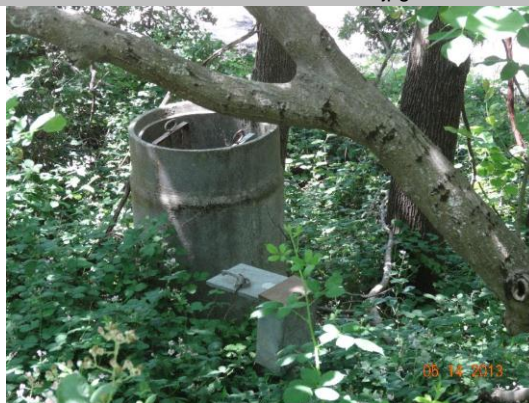
Photo 1 of 1 : UCIP\_1857.jpg

LM Start	1.10	Rating **	M	Issue No.	30
LM End	1.10	Issue Type +	En	Location *	LS
Category	Supplemental			GPS Latitude/Longitude	
				Start	End
Item	DWR UCIP Field Study			38.488151 °	38.488151 °
				-121.554513 °	-121.554513 °
DWR ID	DWR_RD0765_01_s_2014_30				
Action/Comments					
Inspector Comments: FS_ID:19580					
EP_NO: N/A					
Repair Type:					
Crossing Status:					
UCIP Comments:					
FIELD_STRUCT_DESC: 6-inch steel pipe through the levee, 2.5 feet below the crown. (USACE-1959). This entry matches the Drainage or Irrigation Structure referenced in O&M manual (RM 50.15).					
FS Date: 5/14/2013

Overview of landward side--concrete standpipe and control panel located at toe.

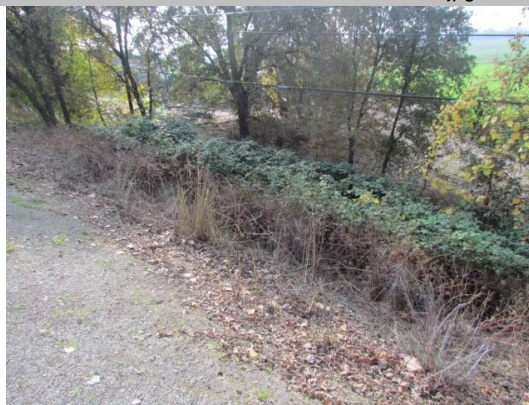
Photo 1 of 1 : richard\_s\_20140303\_107.jpg

Looking southwest at dense vegetation on landside slope and toe.

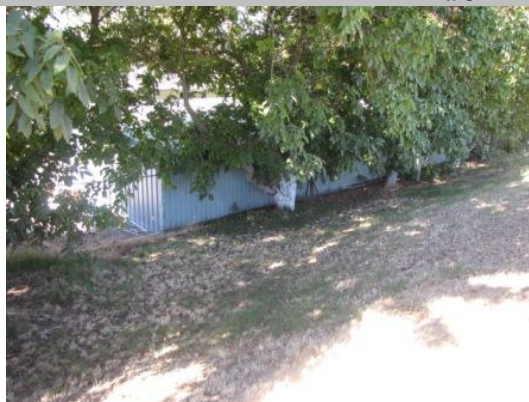
Photo 1 of 1 : richard\_s\_20140303\_105.jpg

Looking northwest at buildings along landside toe.

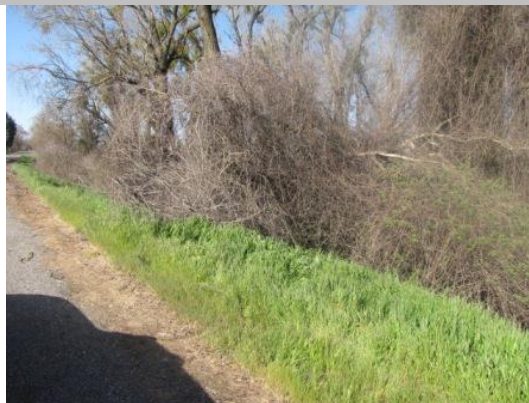
Photo 1 of 2 : richard\_s\_20140303\_068.jpg

Looking upstream (north) at dense vegetation on waterside slope.

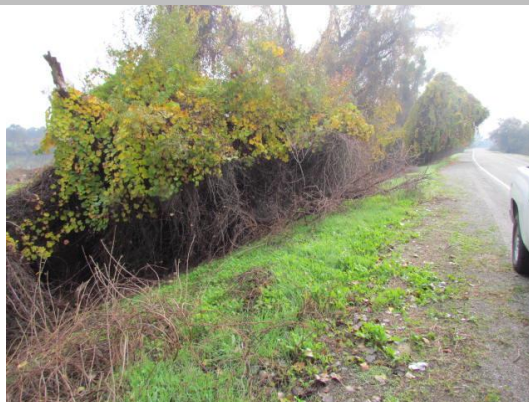
Photo 2 of 2 : richard\_s\_20140303\_069.jpg

Looking southeast at dense vegetation on waterside slope. (Fall Inspection 2012)

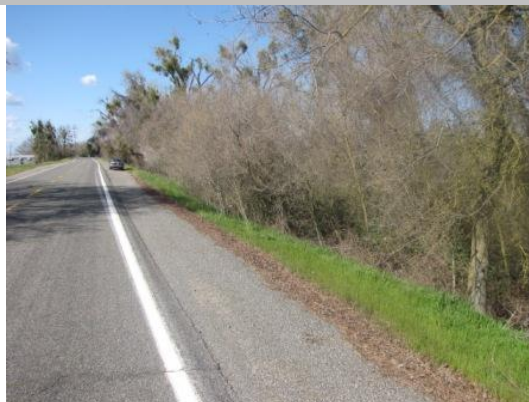
Photo 1 of 2 : richard\_s\_20140303\_066.jpg

Looking upstream (north) at dense trees on waterside slope.

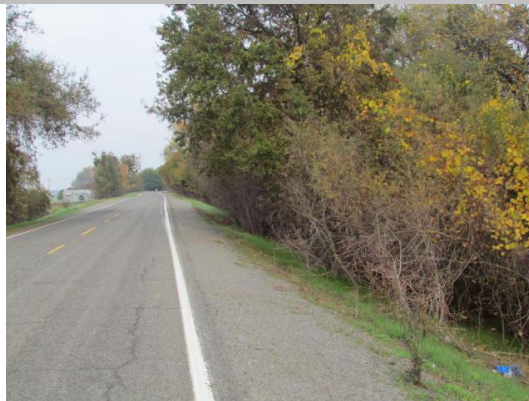
Photo 2 of 2 : richard\_s\_20140303\_067.jpg

Looking north at dense vegetation on waterside slope. (Fall Inspection 2012)

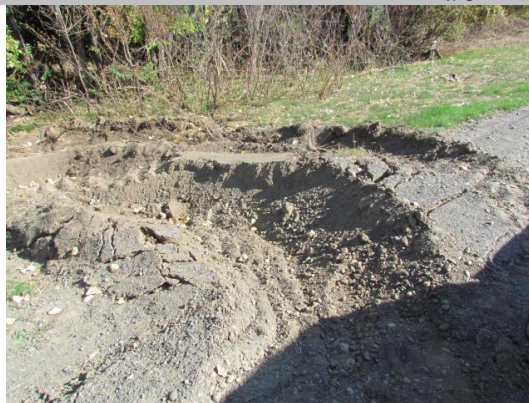
Photo 1 of 3 : richard\_s\_20140303\_084.jpg

LM Start	1.48	Rating **	A/W	Issue No.	19
LM End	1.48	Issue Type +	Ma	Location *	WS
Category	Earthen Levee			GPS Latitude/Longitude	
				Start	End
Item	Slope Stability			38.483353 °	38.483353 °
				-121.551457 °	-121.551457 °
DWR ID	DWR_RD0765_01_f_2013_19				
Action/Comments					
Repair the levee slope damaged by vehicle traffic and prevent access

Looking southeast at slope damage on waterward slope.

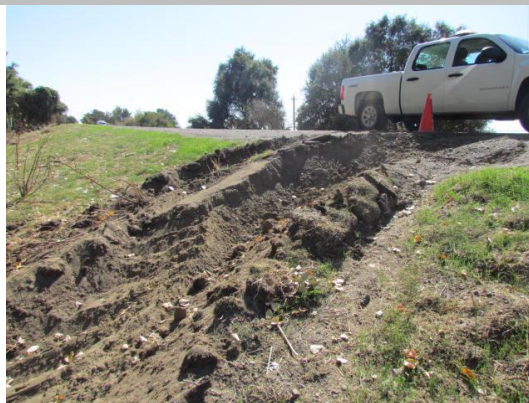
Photo 2 of 3 : richard\_s\_20140303\_085.jpg

Looking southwest at slope damage on waterward slope.

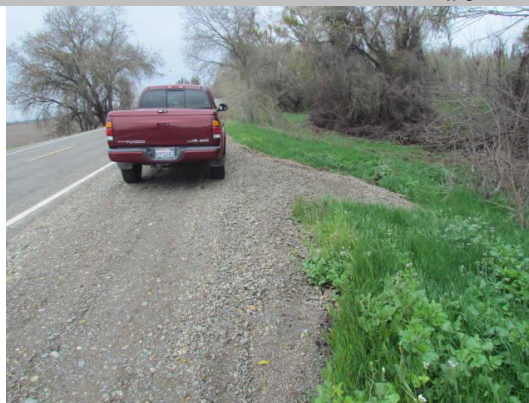
Photo 3 of 3 : richard\_s\_20140305\_131.jpg

Looking north at repaired slope damage on waterward slope.

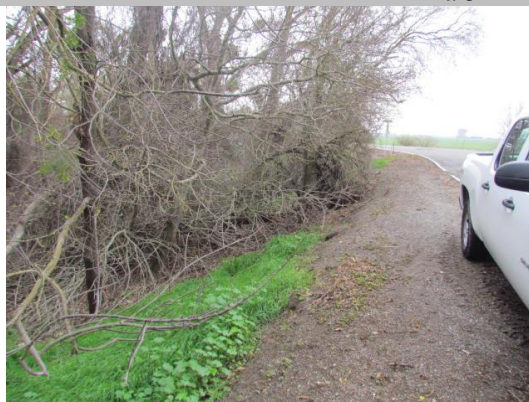
Photo 1 of 2 : richard\_s\_20140305\_124.jpg

Looking southeast at vegetation on waterward slope.

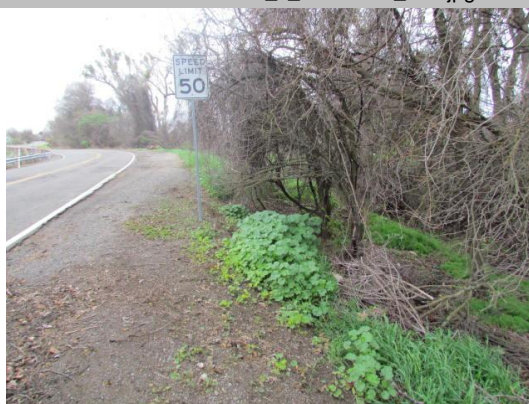
Photo 2 of 2 : richard\_s\_20140305\_125.jpg

Looking north at vegetation on waterward slope.

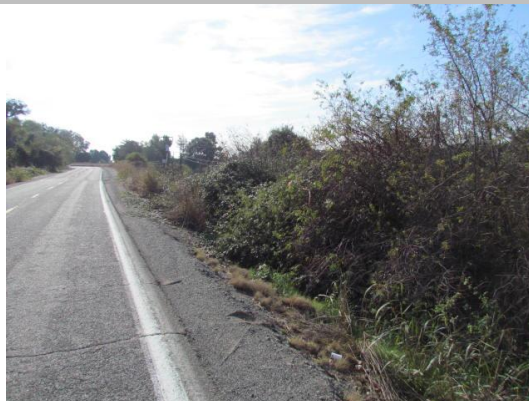
Photo 1 of 5 : richard\_s\_20140303\_090.jpg

Looking south at dense vegetation on landside shoulder and slope.  
(November 2011)

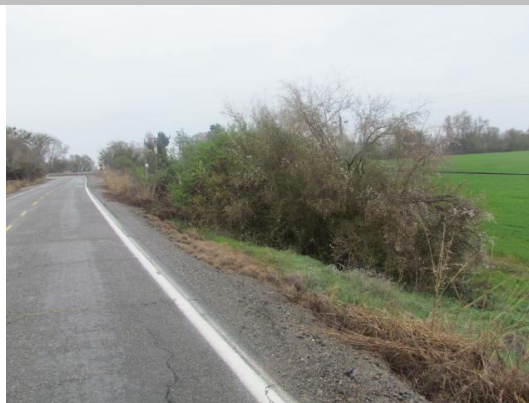
Photo 2 of 5 : richard\_s\_20140303\_091.jpg

Looking south at dense vegetation on landside slope and toe spring  
2012.

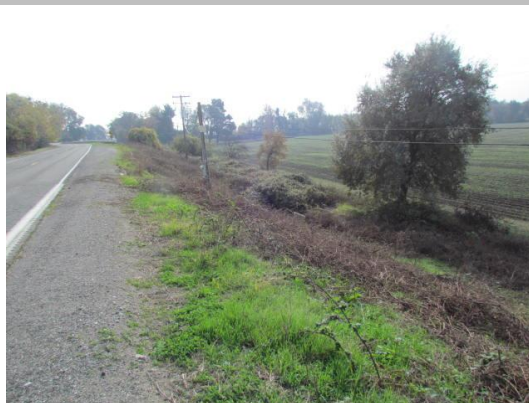
Photo 3 of 5 : richard\_s\_20140303\_092.jpg

Looking southwest at vegetation on landside slope and toe. (Fall  
Inspection 2012)

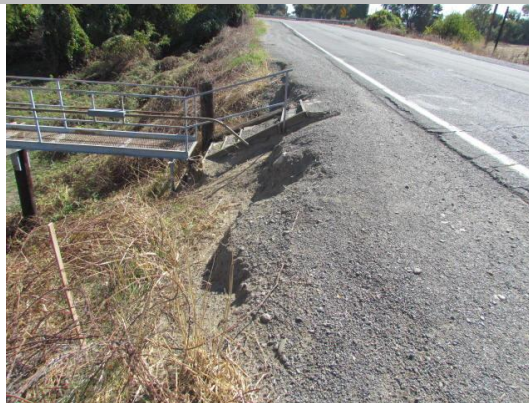
Photo 1 of 4 : richard\_s\_20140303\_070.jpg

LM Start	1.56	Rating **	A/W	Issue No.	8
LM End	1.56	Issue Type +	Ma	Location *	WS
Category	Earthen Levee			GPS Latitude/Longitude	
				Start	End
Item	Erosion / Bank Caving			38.482414 °	38.482414 °
				-121.550804 °	-121.550804 °
DWR ID	DWR_RD0765_01_f_2013_8				
Action/Comments					
Schedule repair of erosion site prior to the next inspection. Inspector Comments: Erosion located around metal walkway on waterward shoulder and slope.

Looking south at erosion on waterward shoulder.

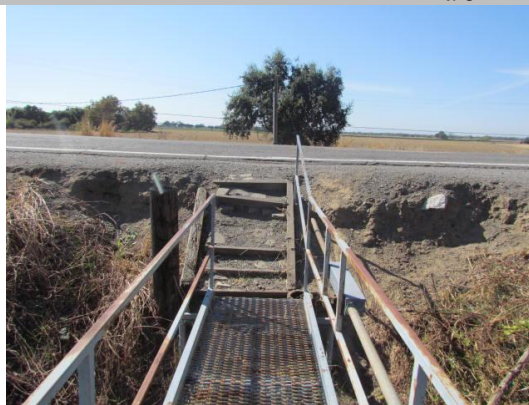
Photo 2 of 4 : richard\_s\_20140303\_071.jpg

Looking west at erosion on waterward shoulder and slope.

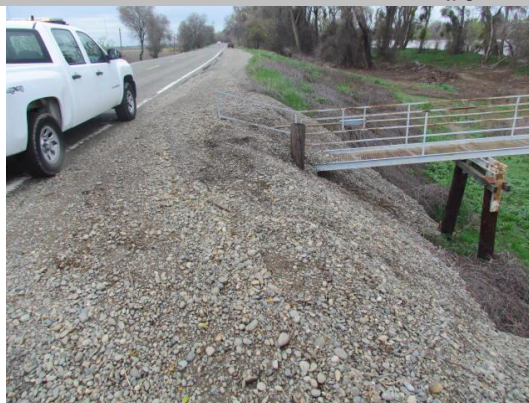
Photo 3 of 4 : richard\_s\_20140305\_129.jpg

Looking north at repaired erosion on waterward should.

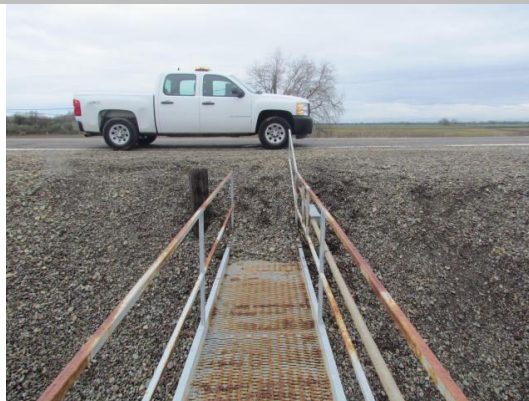
Photo 4 of 4 : richard\_s\_20140305\_130.jpg

Looking west at repaired erosion on waterward shoulder.

LM Start	1.56	Rating **	A/W	Issue No.	8 (cont)	
LM End	1.56	Issue Type +	Ma	Location *	WS	
Category	Earthen Levee			GPS Latitude/Longitude		
				Start		End
Item	Erosion / Bank Caving			38.482414 °	38.482414 °	
				-121.550804 °	-121.550804 °	
DWR ID	DWR_RD0765_01_f_2013_8					
Action/Comments						
Schedule repair of erosion site prior to the next inspection.

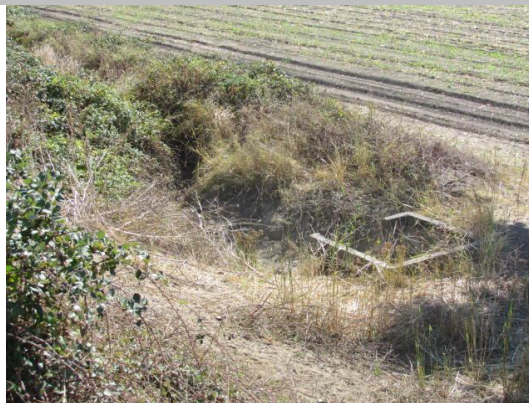
Photo 1 of 1 : richard\_s\_20140303\_116.jpg

Looking southwest at irrigation ditch on landward toe.

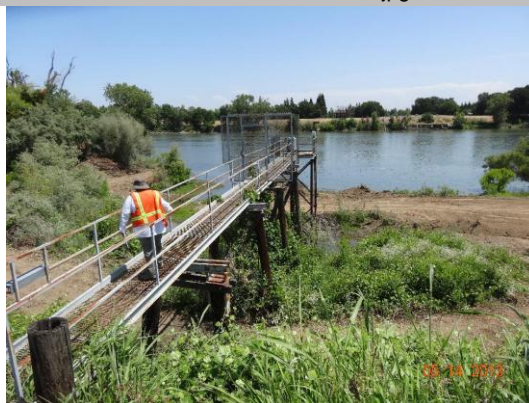
Photo 1 of 1 : UCIP\_1864.jpg

LM Start	1.57	Rating **	M	Issue No.	61
LM End	1.57	Issue Type +	En	Location *	LS
Category	Supplemental			GPS Latitude/Longitude	
				Start	End
Item	DWR UCIP Field Study			38.482290 °	38.482290 °
				-121.550769 °	-121.550769 °
DWR ID	DWR_RD0765_01_s _ 2014_61				
Action/Comments					
Inspector Comments: FS_ID:19581					
EP_NO: 12862					
Repair Type:					
Crossing Status:					
UCIP Comments:					
FIELD_STRUCT_DESC: 14-inch steel pipe sleeved through 16-inch steel pipe through the levee, 20.3 feet below the crown. Gate valve on the waterward side. Pump on piling (platform) in the stream, walkway to the pump. Service pole on the landward slope. (USACE-1959). This entry matches the Drainage or Irrigation Structure referenced in O&M manual (RM 49.68). 14-inch steel pipe added under Permit No. 12826 (1980). Annular gap grouted.					
FS Date: 5/14/2013

View of waterward side--walkway, support piles, access gate and pump.

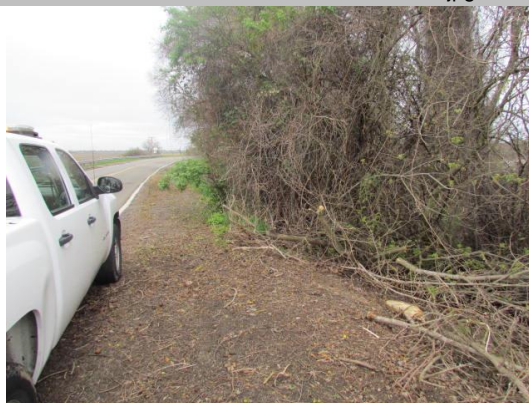
Photo 1 of 1 : richard\_s\_20140305\_128.jpg

Looking north at dense vegetation on waterward slope.

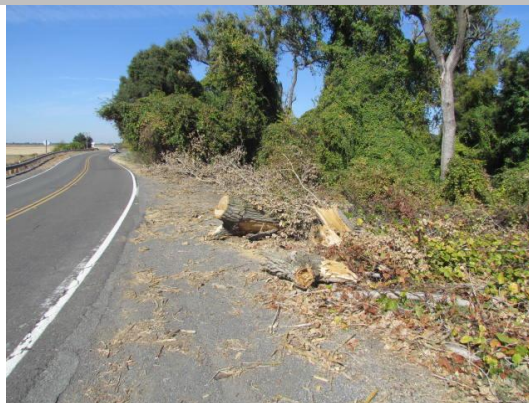
Photo 1 of 3 : richard\_s\_20140303\_077.jpg

Looking northeast at tree limbs on waterward slope.

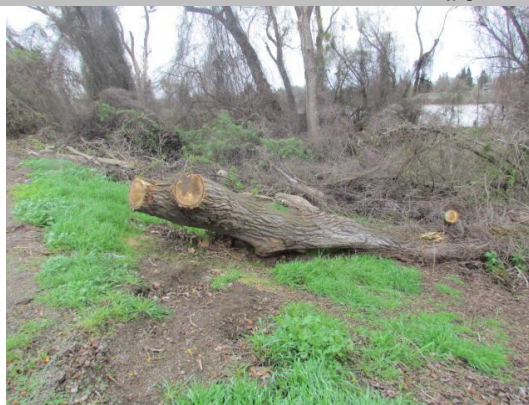
Photo 2 of 3 : richard\_s\_20140305\_126.jpg

Looking north at large tree limb on waterward slope.

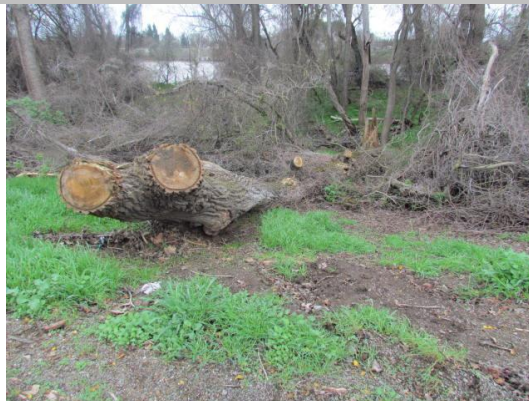
Photo 3 of 3 : richard\_s\_20140305\_127.jpg

Looking east at large tree limb on waterward slope.

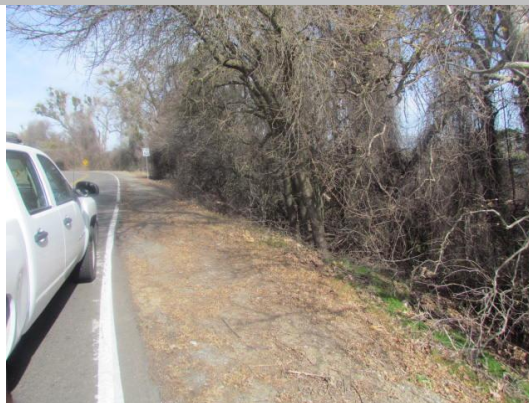
Photo 1 of 1 : richard\_s\_20140303\_111.jpg

Looking north (upstream) at dense trees on landside slope.
